# Housing Morphology in Clerkenwell

## Cavendish Mansions, Clerkenwell Road

Fieldwork & Analysis carried out by Hede Wojgani & Nena Singh

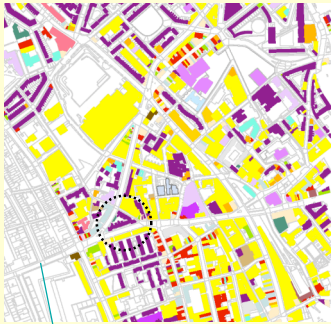
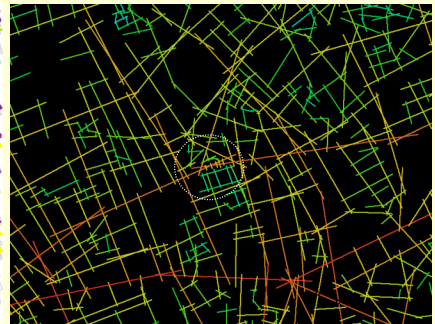
Today, this is an inner city estate situated in a traffic island i.e. surrounded by vehicular streets on all sides. Given the high integration value of Clerkenwell Road in the global scale and the diverse land use around its periphery, this is a well integrated urban block. The residents are from various social & cultural backgrounds and are appreciative of the presence of most amenities in the neighbourhood, except playgrounds. Generally, this is located in close proximity to an area undergoing rapid redevelopment and a perceptible upgradation. From the scattergram, we note that the peripheral streets are globally well integrated.

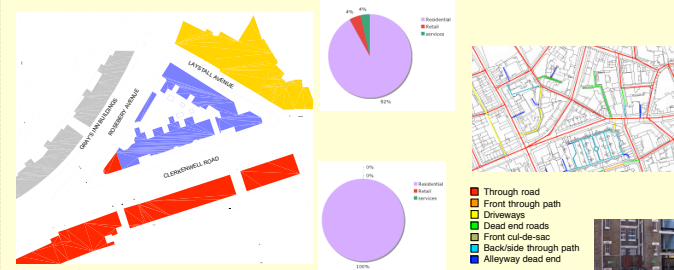
This is a very dense block accessed from two sides leading to a central courtyard. All entrances into the estate are regulated resulting in an almost fortified complex with four doors leading off the Clerkenwell Road. As the convex analysis shows, the pavement is a part of the system of the estate. The VGA analysis also confirms this and shows that the courtyard functions as one spatial entity and not a complex of convex spaces. Most of the frontage has windows & upper visibility which ensures constant surveillance and almost all frontages are punctured by doors. The high See through fence provides transparency while demarcating public from private. The land use Shows efficient usage of area with about 50% given to the units.
